Manhole Inspection Summary

Manhole # S39W1_024MH

Insp Date: **11/15/07 9:18 AM**

Location Address: **3545 Horton Ave**

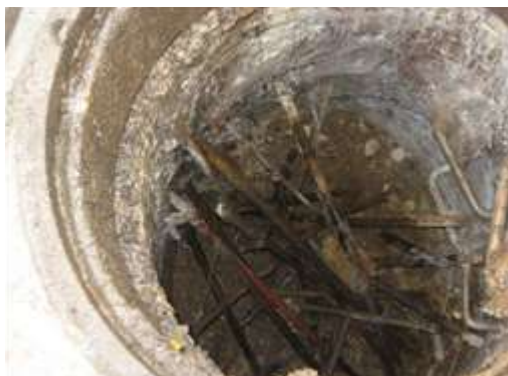
Defect 2

Condition: ☐ Sound ☐ Cracked ☐ Root Intrusion ☐ Deteriorated ☐ Leaks ☒ **Debris**

Debris

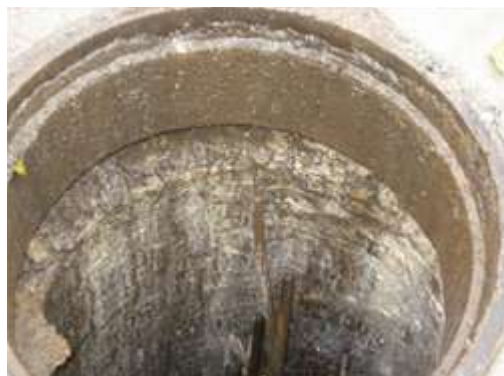
Defect 1

Comments **Chimney has deteriorated/loose brick & mortar**

Condition: ☐ Sound ☐ Cracked ☐ Root Intrusion ☒ **Loose Brick** ☒ **Deteriorated**

Deteriorated chimney

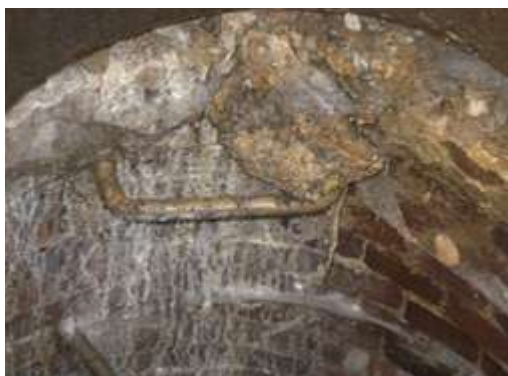
Defect 3

Infiltration: ☐ None ☐ Joint ☐ Cracks ☒ **Mortar** ☐ Roots ☐ Wall

Infiltration: ☐ None ☐ Joint ☒ **Cracks** ☒ **Mortar** ☐ Roots ☐ Wall

Loose Mortar

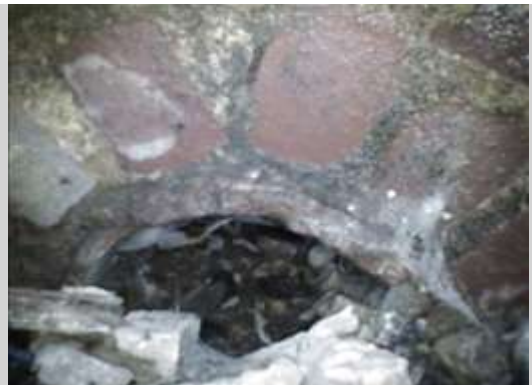
12 O'Clock Outflow

8 in. Circular Gravity Sewer
Pipe Out @ 12 O'Clock

Debris/Closed

Deposits: ☐ None ☐ Mud ☐ Sludge ☒ **Debris** ☐ Grease

Silt Depth: **5** (in.) Deposits Extent: **Heavy**
